Mekelle University

Ethiopian Educational Network to Support Agricultural Transformation (EENSAT)

Field Report to the field visit to Upper Tekeze

12-14 February, 2018

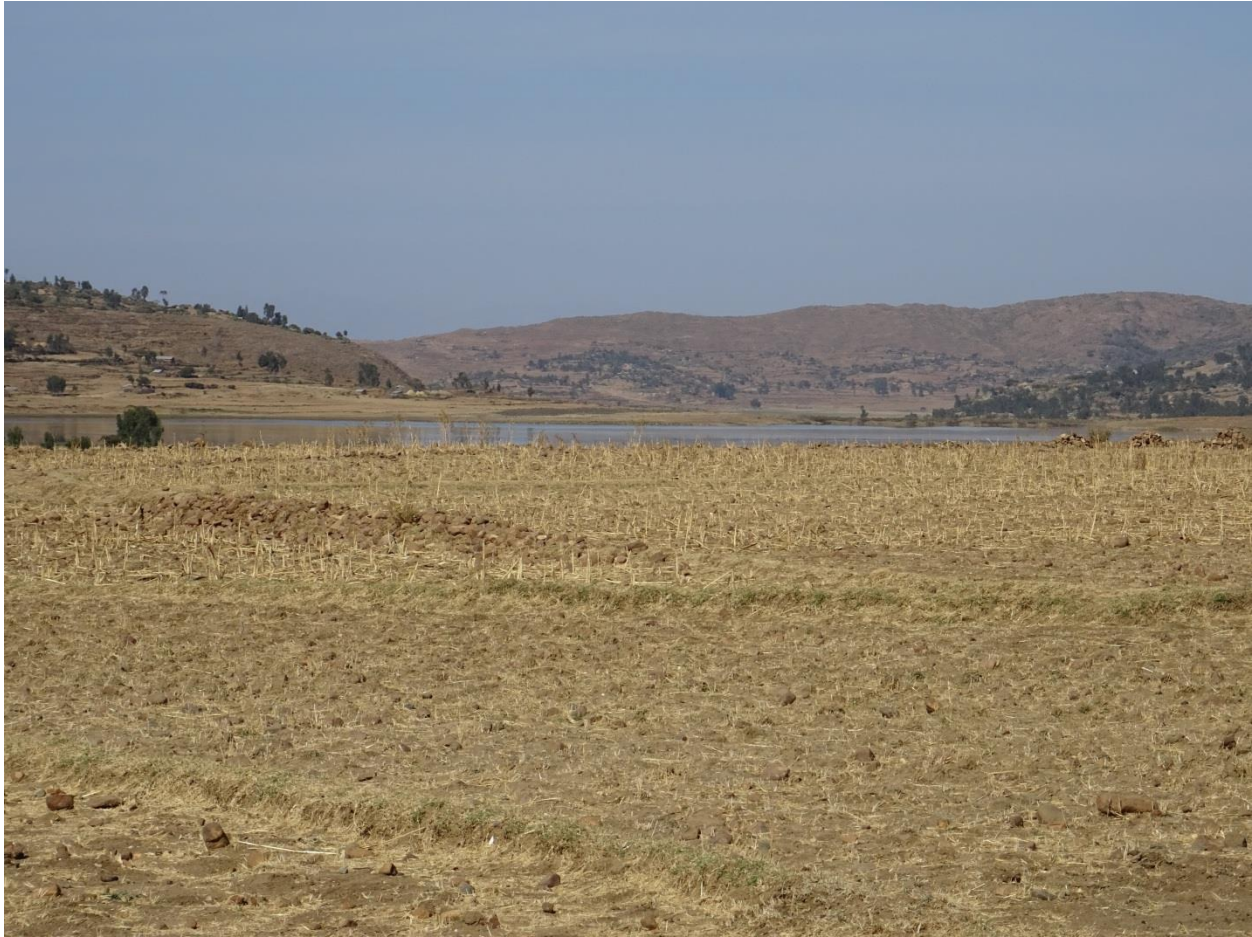
In 1994-95 Meila, Haiba and other micro dams were constructed for water harvesting and irrigation development in Tigray. However, they are found highly vulnerable to siltation and seepage in response to excessing soil erosion and sediment export and leaky foundations. Some of these dams are cascading dams and are in the same catchment. It was discussed that the water quality of the two dams clearly demonstrate huge difference in terms of sediment load (turbidity) the first dam (Meila) has high sediment concentration compared to Haiba dam probably due to steep and rugged topography and also erodible soils of the dam catchment derived from Basalt. This dam also traps sediment which would otherwise transported to the Haiba dam in the downstream. Dams that trap sediment can also be used for measuring soil erosion with implication of lose of storage capacity and lose of intended use for irrigation development or hydropower generation. It was also presented that to assess the sediment yield in the reservoirs Bathymetric survey using Echo-sounder was conducted in 2016 by one MSc student at I-GEOS.

Figure 2: Haiba dams at the headwater catchment of Arequa River.

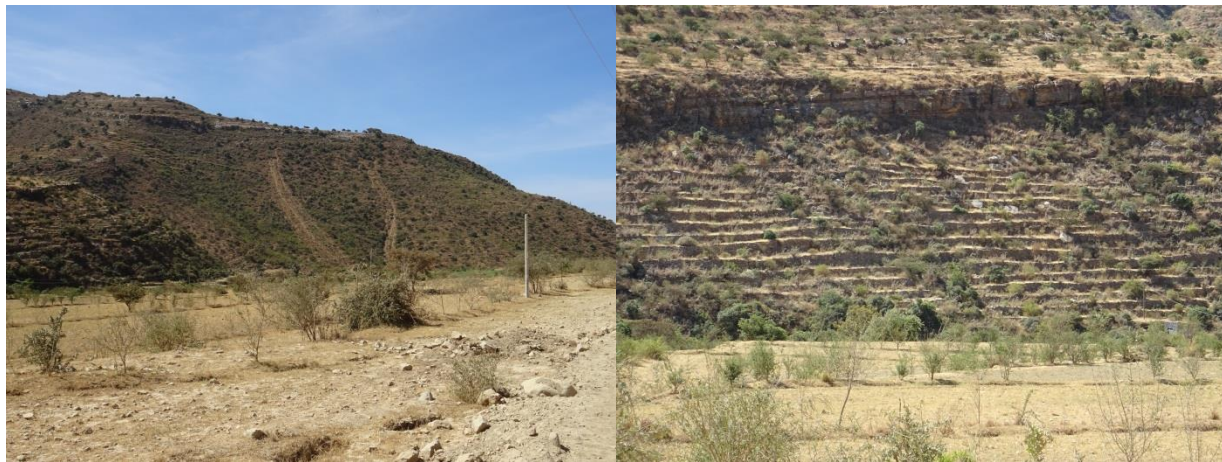
Land slide is common in areas where there is marl and shale formation. These geological formations usually weather into clay material acting as a ‘brown-sop’ inducing landslide. Landslide can also be induced due to soil and water conservation interventions by increasing infiltration and increased hydrostatic pressure particularly in exclosures. The area is vegetated and there is no large catchment area above the landslide area (see figure 3) and therefore, the reason for such landslide cannot be different from those reasons mentioned above. Massive conservation with drip irrigation from river and agroforestry is observed in this area. As can be seen in Figure 3 (Left) two parallel recent landslides are observed. These landslides have caused damage to the seedlings planted at the foot slope of the area while supplying sediment to the river.

Figure 3: Hillslope without (left) and with (Right) land rehabilitation in the form of Soil and Water Conservation.

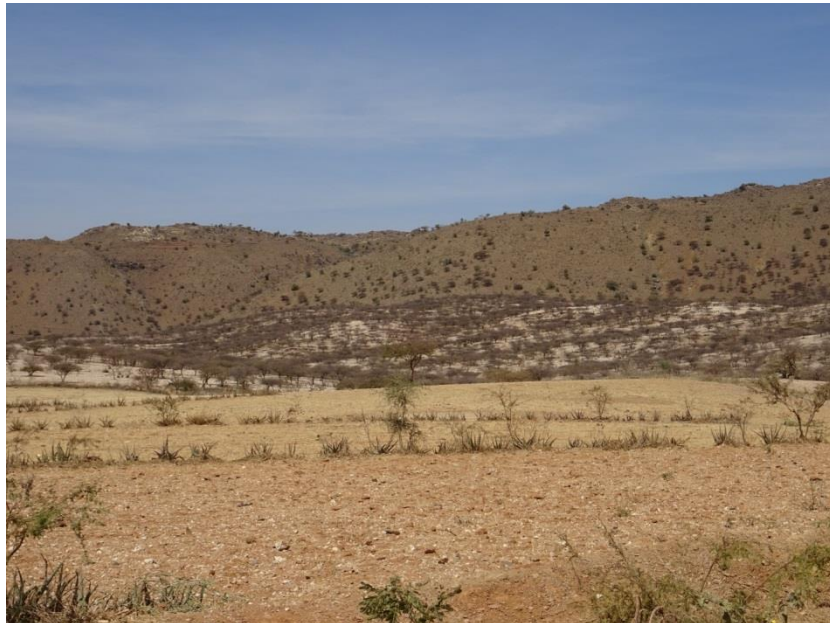
Shift in geological formation is common as one travel from the highlands of Mekelle area to the lowlands. There is a shift from sandstone-limestone formation to Precambrian complex, and metamorphosed sandstone and limestone formations as well as slates. We started from Mekelle area: typical highland characterized by Mekelle outlier in terms of geological formation i.e. series of alternating sandstone and limestone layering with tertiary basalt on the top of Amba Aradom formation. We moved to down from Samre reducing the altitude as a result the geology, natural vegetation and cropping system shift to a large extent. Cropping system is mainly dominated by barley, wheat and *teff* based system. The geological formation shifted from Amba Ardom sandstone to Precambrian formation composed on slates and conglomerates. The natural vegetation is dominated by acacia species as the so called Tiger skin vegetation (Figure 4). The natural vegetation is shifted from olea and Juniprous dominated highlands to Acceia dominated midlands. The area indicates that there was high erosion. This area is the most eroded area and livestock is dominant.

Figure 4: Tiger-spot vegetation in the lowland areas with the hills devoid of vegetation cover and highly affected by rill erosion.

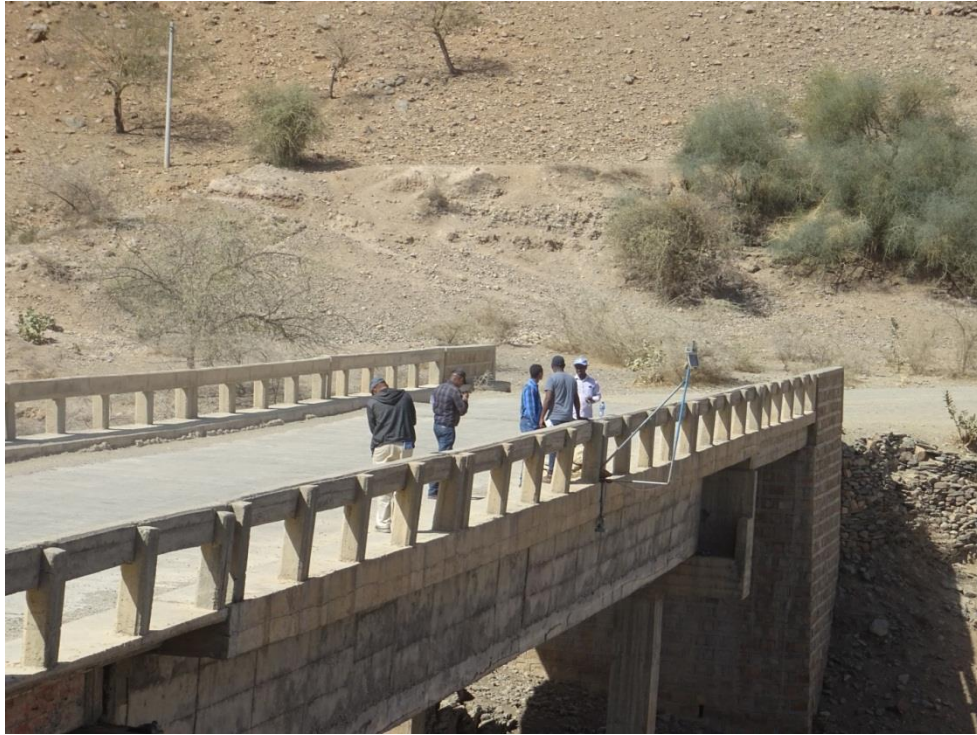
Continuous water stage measuring sensor is installed at the bridges of the Zamra (Figure 5). The instrument measures the height between the instrument and the top surface of the water. The depth of the stage is calculated from the river bed. The river bed is assumed to be stable or changes very slowly. Monitoring of sediment concentration is also made by collecting depth integrated runoff and sediment sample at different points along the river cross-section.

Figure 5: Sensor installed at the bridge of River Zamra for monitoring of depth of the flow (stage).

- Extreme floods measurement is very challenging and need focus,
- Sediment measurement is manually and challenging during flush floods,
- Any gauging station to be installed should be done in communication with MoWRI for sustainability,
- Runoff response of these types of geological formation not understood well,
- Water abstraction by opportunistic irrigators along the river bank and its impact on the livelihood, food security and water balance not known,
- Elements at risk and how the opportunities in this river can integrate with water resources are not identified.

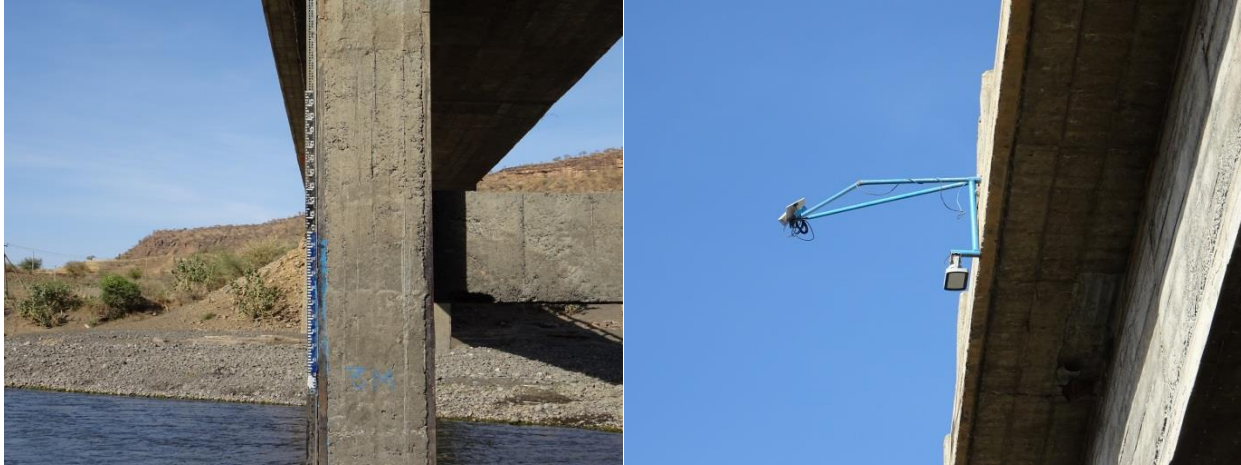
Similar type of instrumentation is also installed at the Bridge of Tsirarie River. Field observations and discussions for the day were completed at Tsirarie River. Around the gauging station: *teff* and sesame are the dominante cultivated crops. The rainy season is mainly formulate June- August as “*Kiremt*” and from March to May as “*Belg*”. The participants and a local farmer indicted that there are abstraction and transmission losses through the river watercourses. In this stop, the rainfall patter, measuring of extreme events, the runoff and sediment yield versus volcanic geological formations were mentioned as key research gaps. EENSAT project should also work in collaboration with other projects in the University and the Ministry of Water, Irrigation and Energy to get access to the data available for the project works.

Figure 6: Sensor installed at the bridge of River Zamra for monitoring of depth of the flow (stage).

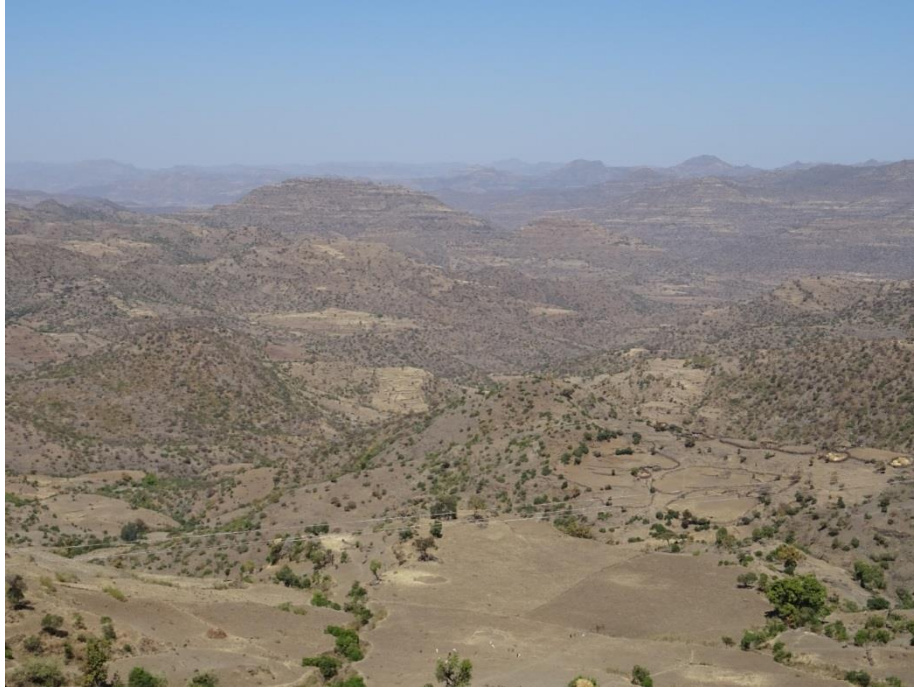
The landscape is highly mountainous with volcanic basalt dominated. The vegetation is increasing in areas where we go from Sekota to Lalibela. Degradation is high with parched/ small cultivated area.

Figure 6: Parched cultivated area in the landscape

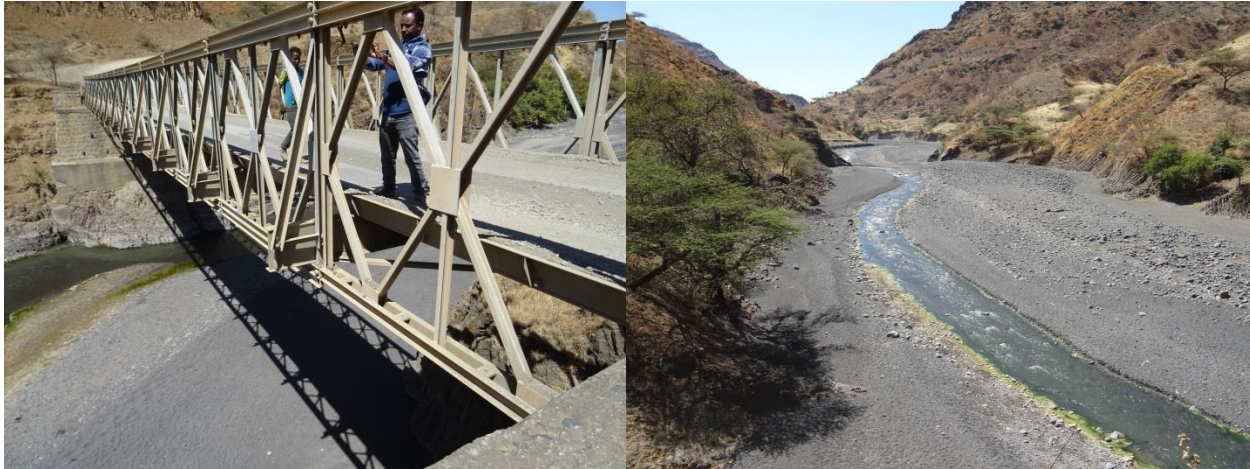
Shift in geological formation is common as one travel from the highlands of Mekelle area to the lowlands. There is a shift from sandstone-limestone formation to Precambrian complex, and metamorphosed sandstone and limestone formations as well as slates. Basaltic geomorphology with long Dike crossing the river was observed (Figure 7). A potential place for establishing hydro- metrological station was observed at the bridge in the border between Tigray and Amhara regional states. The place was at Silla with established guard station where it could be safe for runoff gauging stations. The guard in the bridge said that there are wild animals like lion, tiger, snake, monkey around this site.

Figure 7: Tsirare River Bridge and its geological formation of the lowlands

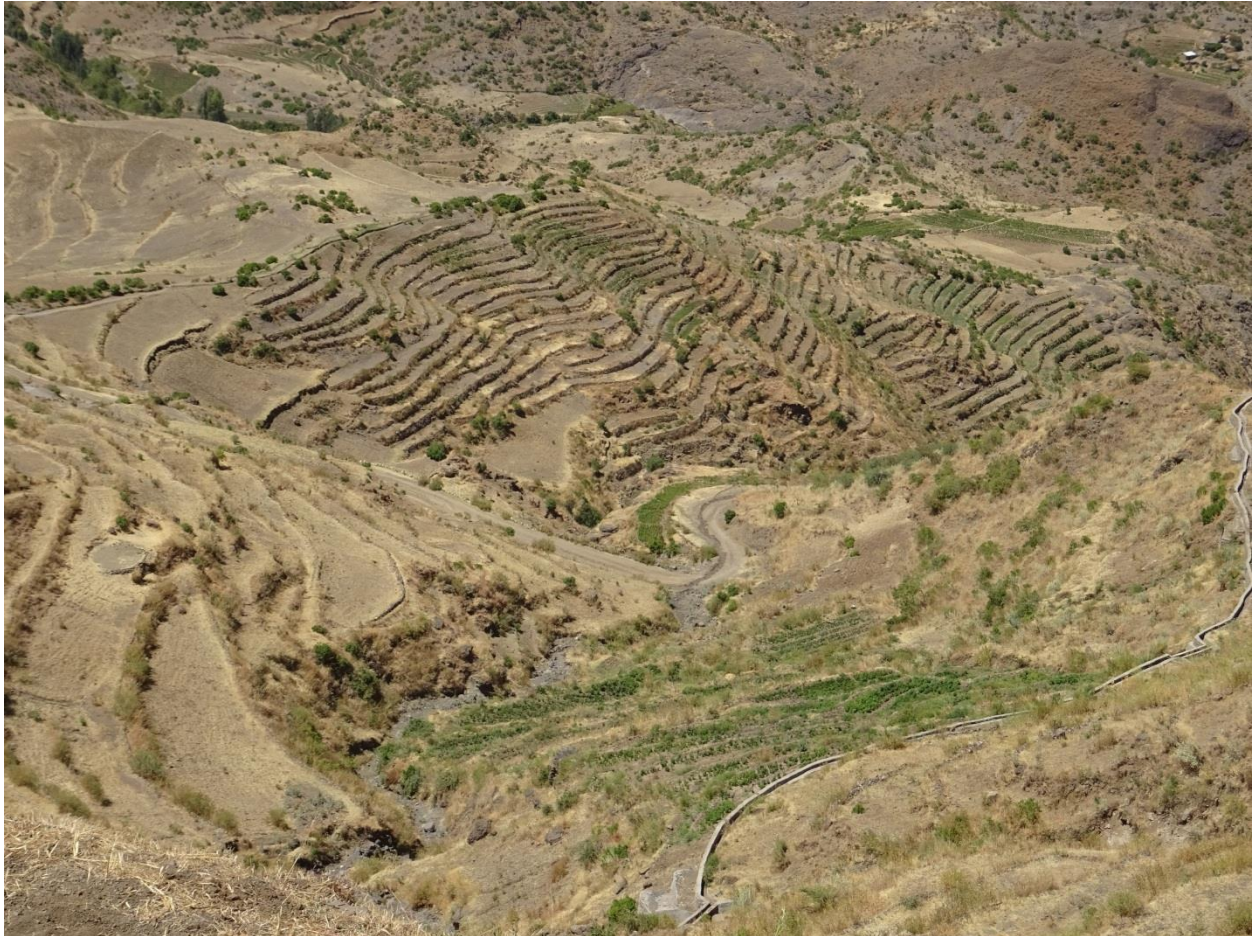
Tigray is characterized as mountainous region with rugged topography and only 19% of the region is suitable for agricultural development. The regional government in collaboration with non-governmental organizations started hillside development mainly using intensive bench terrace and irrigation (Figure 8). Where the soil depth is sufficiently deep and water sources can be made available for irrigation, the hills can be developed for plantation of perennial fruit trees and irrigation and finally handed over to landless and particularly young farmers for continued and sustainable management of the hills.

Figure 8: Hillside development with bench terraces and irrigation technology for mainly perennial fruit trees.

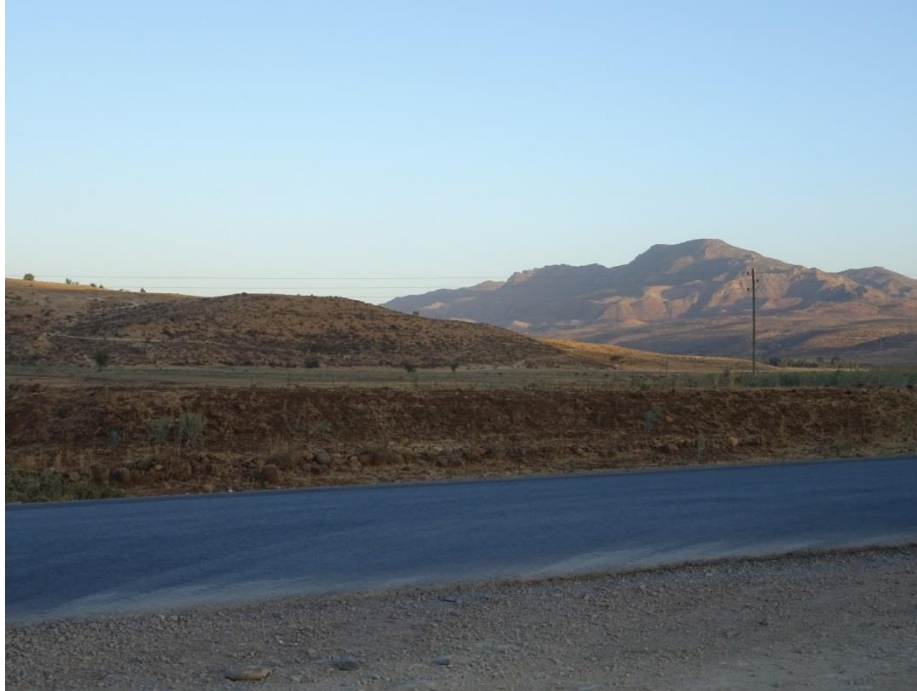
Gumero is located approximately 50 km South of Mekelle within the headwater catchment of Zamra River. The area is generally characterized as rugged topography, deeply incised by the Zamra River. Due to slope instability the area is highly affected by different types of geomorphic processes including land sliding. As can be evidenced from the sediment concentration in the river, the area is highly affected by erosion processes. Many dams around this area were failed because of siltation and seepage.

Figure 9: Different geological formations and water resources developments.
